Diagnosing Well Related Problems Utilizing Digital Camera Video Recording Technology

Beard, G.H./1 Vendrell, P.F./2

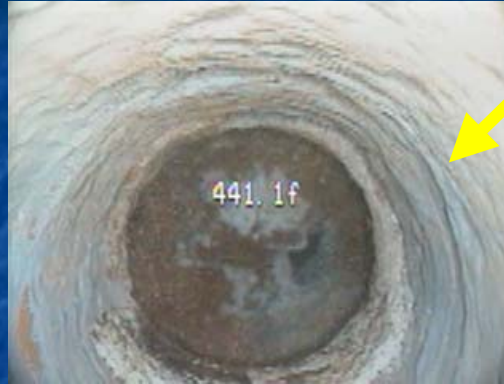
Inspection 1: The first well that was inspected using this system was at a Colquitt County poultry house. The problem associated with this inspection was that the filter at the well continued to clog soon after it was cleaned or replaced making it impossible to obtain clean water for the chickens. The down well system revealed that the well had collapsed below the casing at approximately 441 feet causing sediment problems which clogged up the filter system.

Inspection 1: After the agents determined the approximate depth (accurate to within 1 foot), the well driller re-drilled the well and cleaned out the area that had collapsed. At the depth of collapse, the well driller installed a screen which would hold back the loose sediment that was associated with that particular soil layer. Dr. Paul Vendrell, Ag Services Laboratory and water specialist, was on site during the inspection, so it was not necessary to upload the digital video for further inspection and diagnosis.

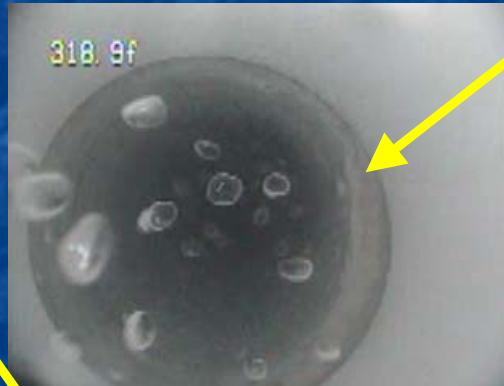
Inspection 2: The second well inspection initiated by the agents was at a private residence and revealed that there was some type of natural formation just below the casing at approximately 320 feet and was emitting some type of gas (possibly carbon dioxide or methane) which in turn was causing the pump to burn up because it was losing prime because of the bubbles. The gas was observed in a bubbling action that was emitted at a crack or fissure along the well wall

Inspection 2: After the agents determined the approximate depth to the phenomenon, they then attempted to determine the type of gas that was being emitted. A field test to trap some of the gas was initiated by installing a plastic bag over the top of the well head and sealing with black electricians tape. This device was then left in place for approximately 20 minutes. The agents observed that the bag was beginning to fill with the gas and after a period of time, atmospheric equilibrium was reached and the bag ceased to fill with the gas. The bag (with the gas trapped inside) was removed and a flame was introduced in order to determine if ignition would occur. When the flame, which was introduced into the bag, was extinguished, it led us to believe that the gas was not methane in nature. Since the flame self extinguished, our hypothesis was that it was possibly carbon dioxide in nature since all oxygen seemed to be excluded from the test device. These are only assumptions since a lab confirmation was not completed on the gas. Once the precise depth to the fissure was discovered, the agents recommended that an additional length of casing be installed that would put the pump below the area of the fissure and the bubbling gases. The pump was then lowered an additional 20 feet below this area which allowed it to prime. Dr. Paul Vendrell, Ag Services Laboratory and water specialist, was on site during the inspection, so it was not necessary to upload the digital video for further inspection and diagnosis. This action was successful.
