Focus Area: River & Stream Restoration

Regional Review, October 2007

Hatfield Dam Removal Feasibility Study

**River and Stream Continuity Project
On-line Database**

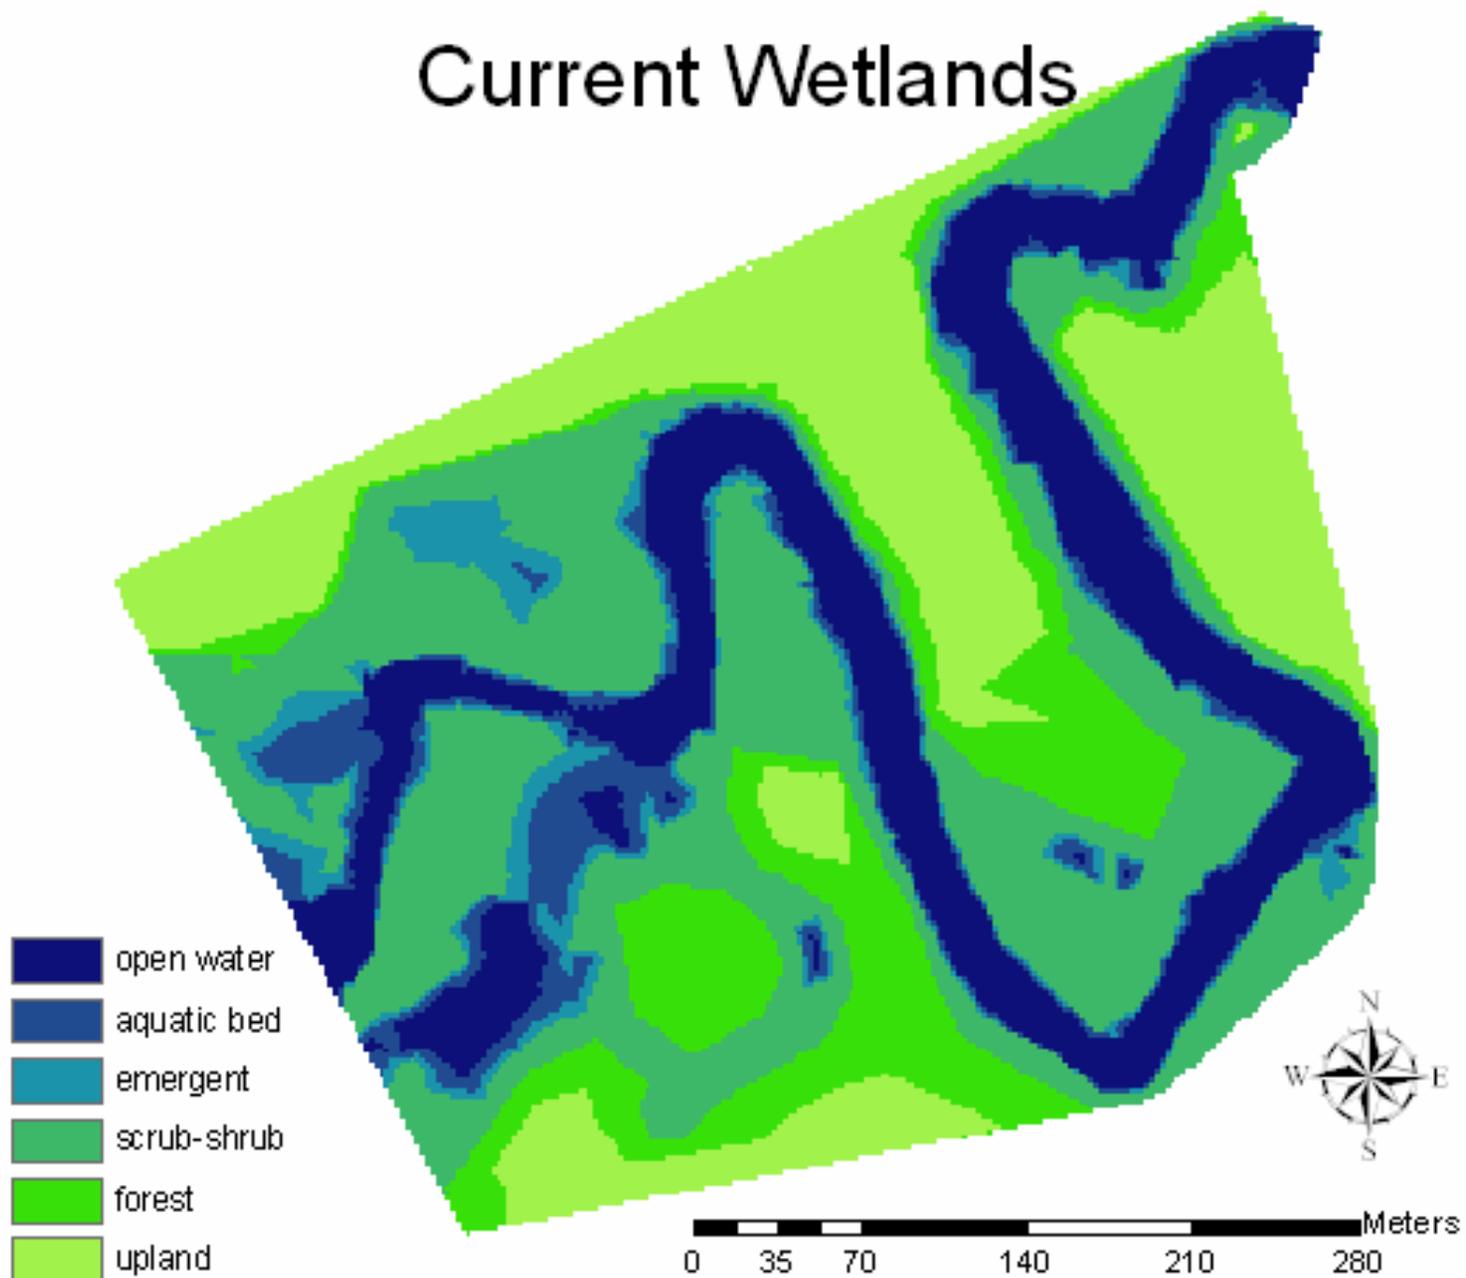
Current Wetlands

Wetland zones were defined based on the minimum and maximum elevations for each wetland type

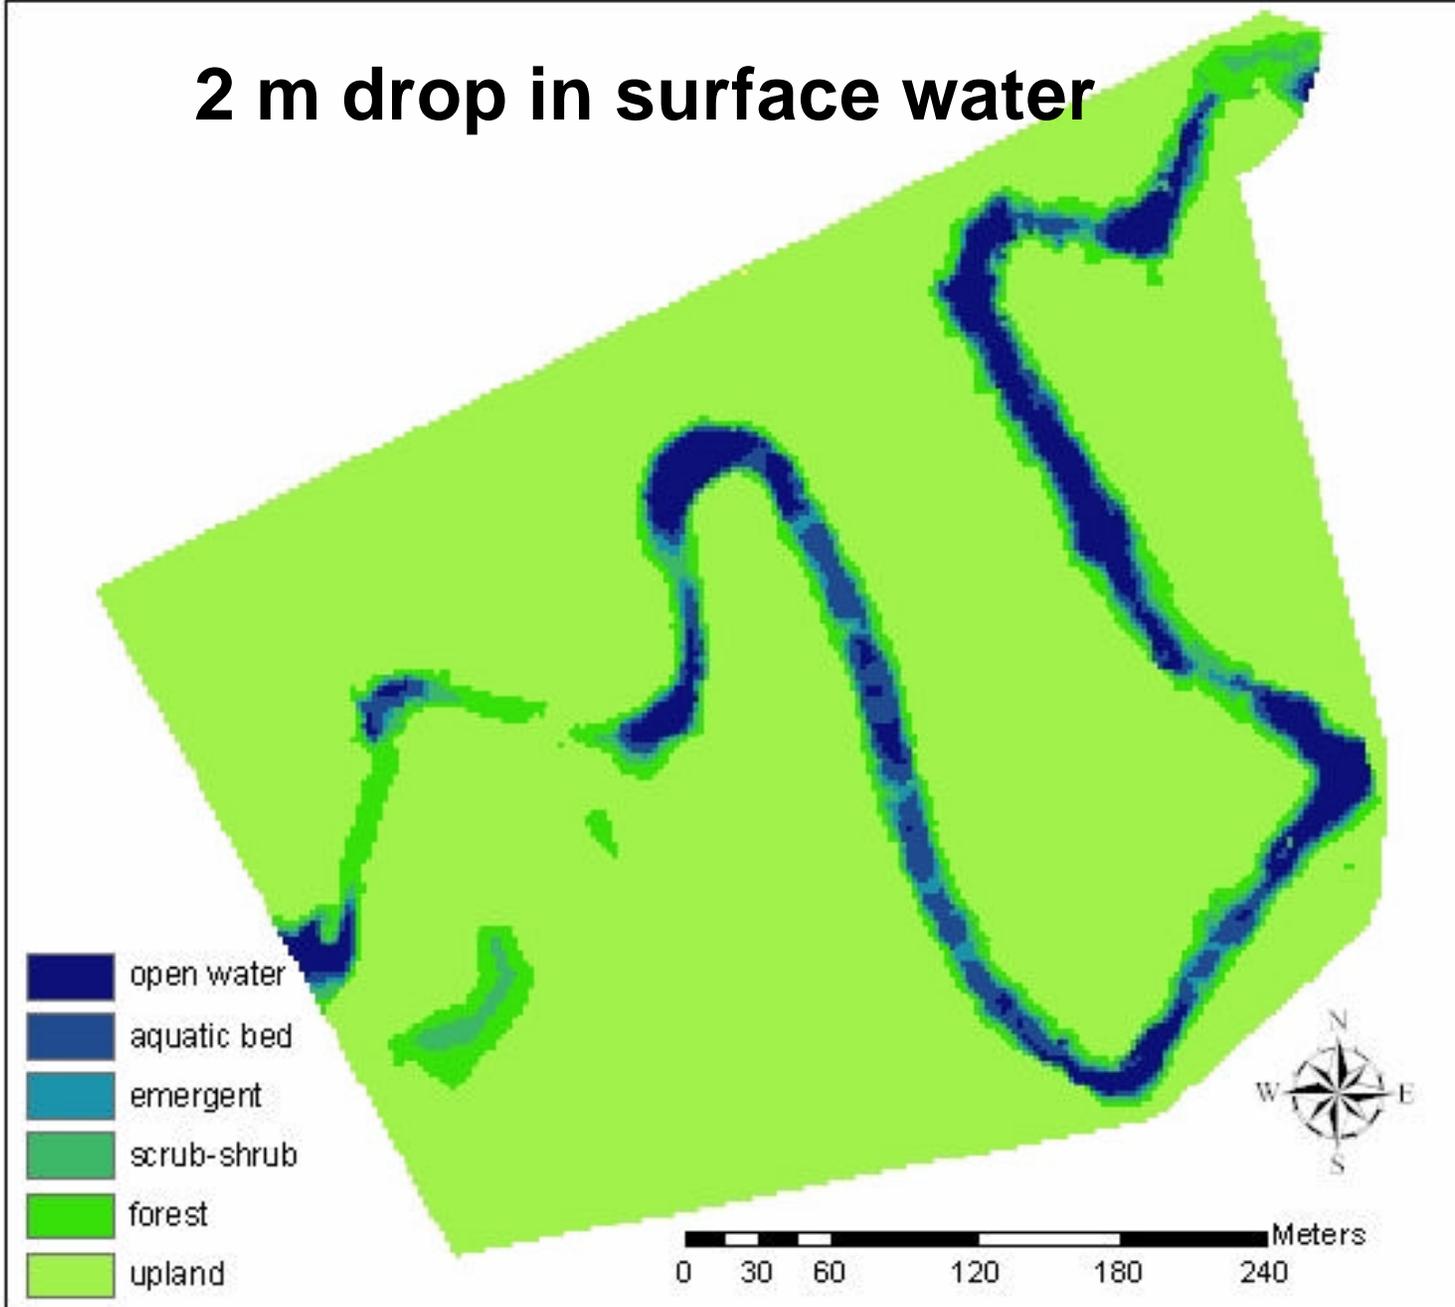
2 m drop in surface water

In the area of greatest impact, dam removal would result in an approximate 73% loss in wetland area

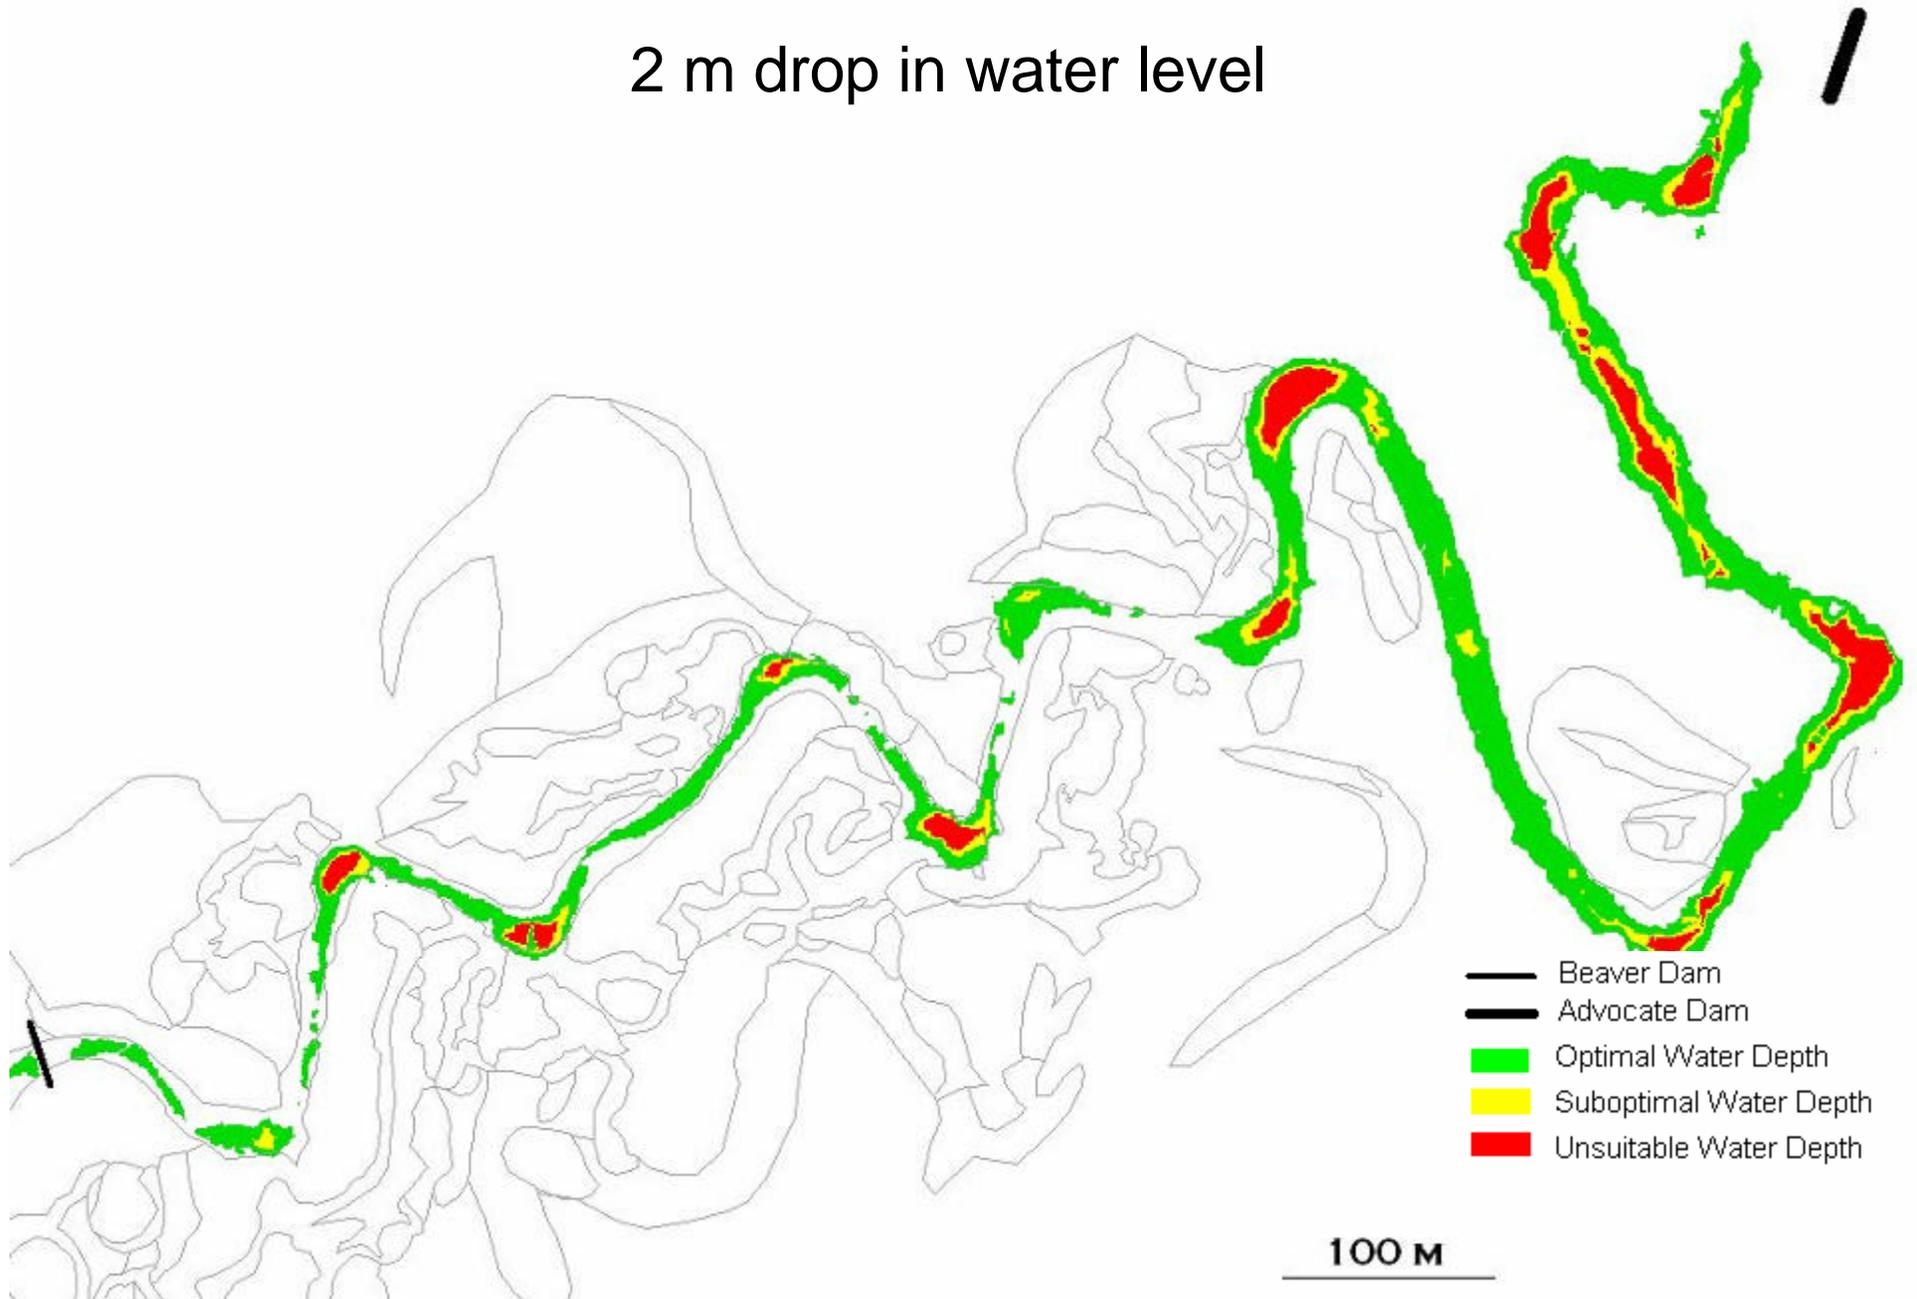
2 m drop in water level

Effective habitat for dwarf wedgemussel:

- Overlap of suitable habitat for dwarf wedge and tessellated darter
- Overlapped with unsuitable bass habitat

Effective habitat current: 18,871 m²

Effective habitat removal: 21,467 m²

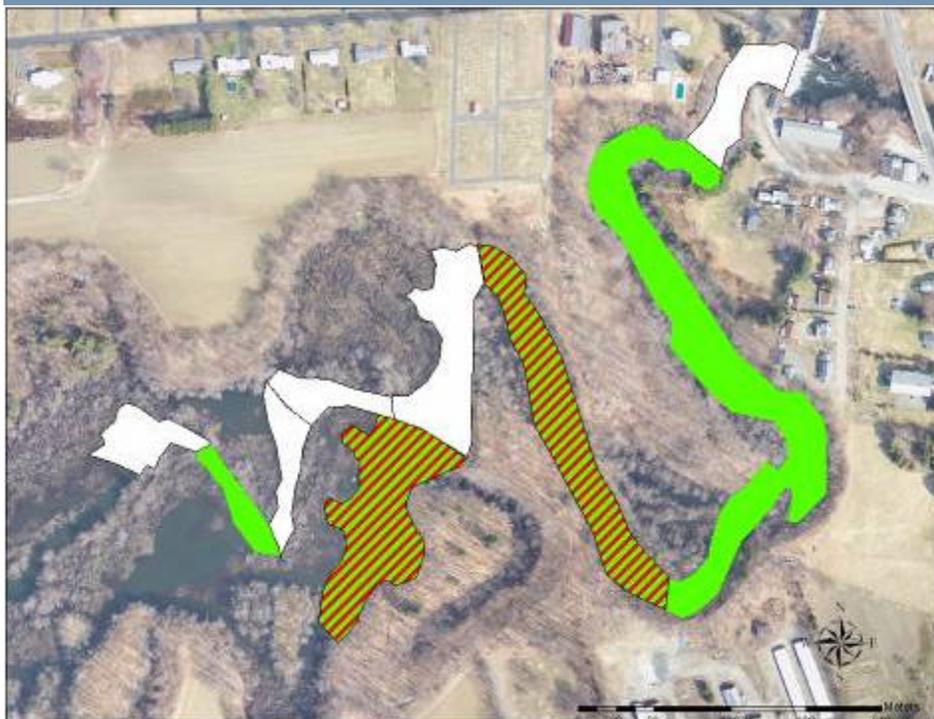
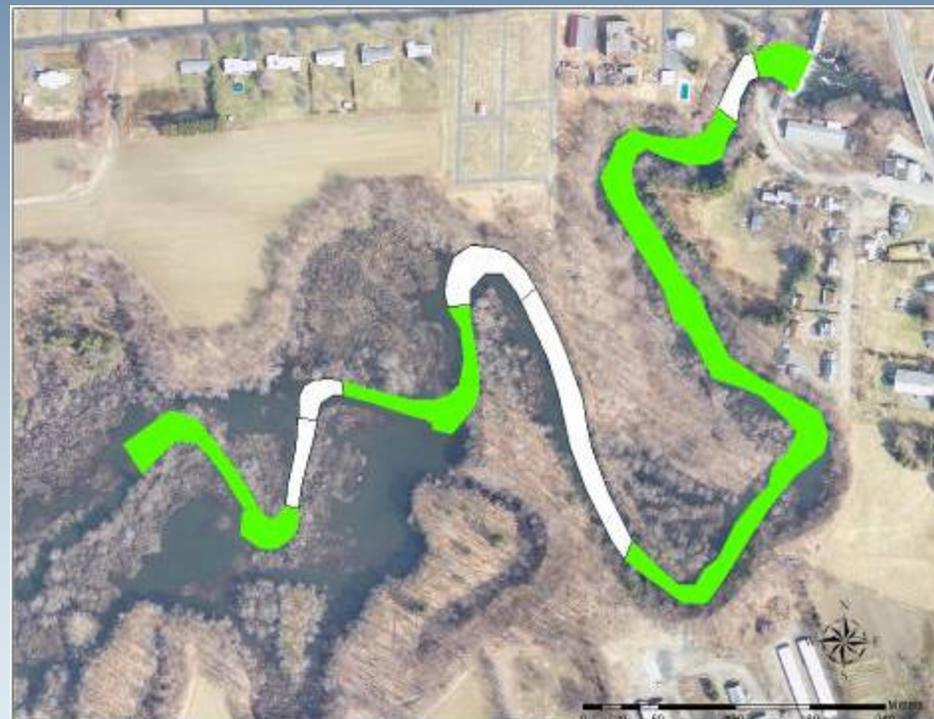
suitable LM Bass
-

no overlap of suitable HMUs
-

overlap suitable dwarfwedge and tessellated darter

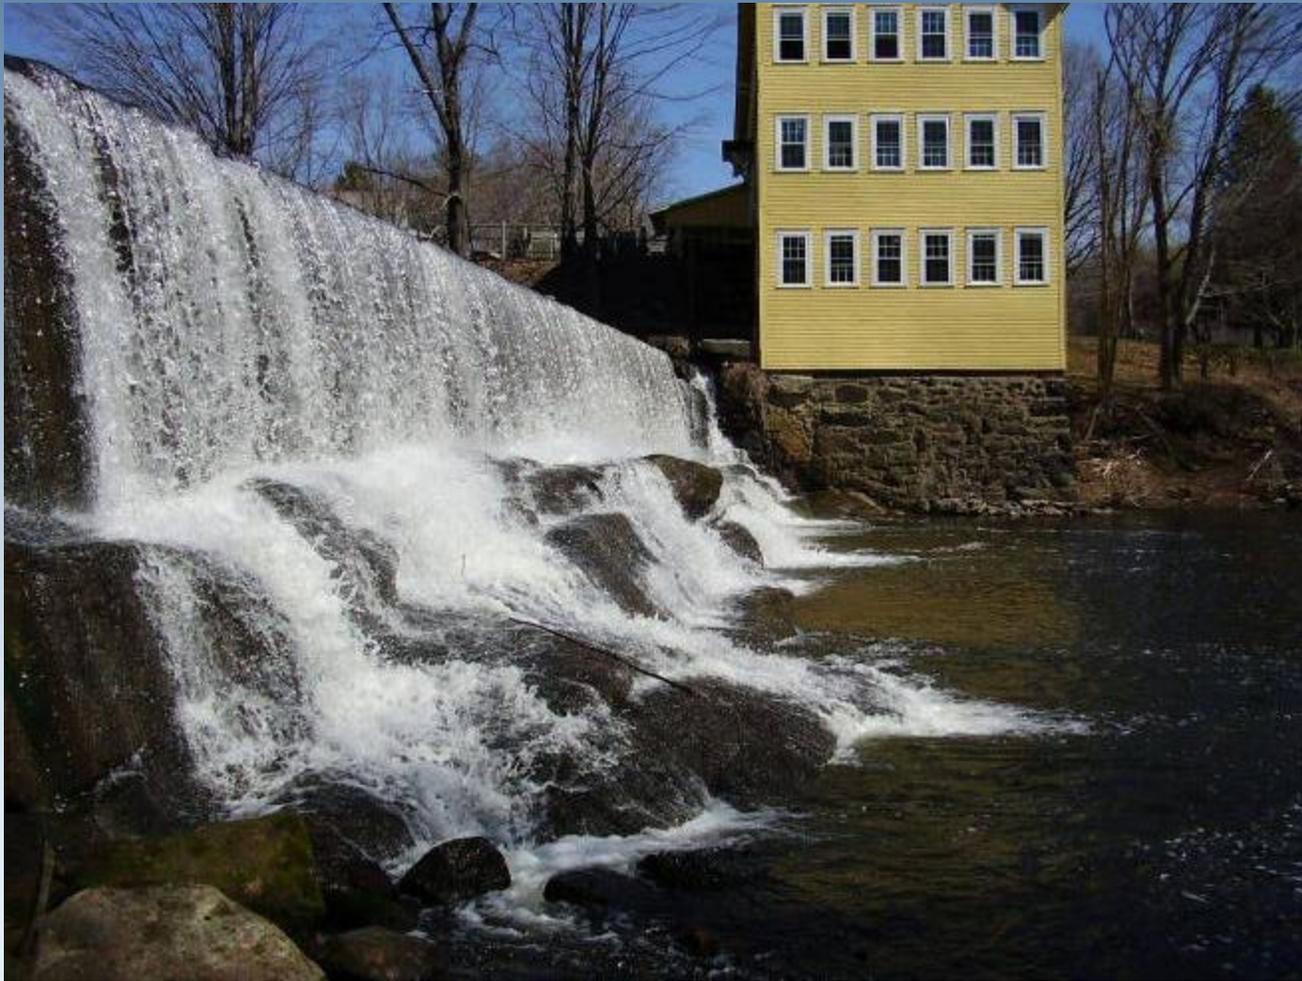
Potential Fish Passage Over Natural Bedrock Ledge Barrier

Removal will significantly benefit:
American eel, Atlantic salmon, and sea lamprey

Provide partial and periodic passage for:
American shad, Blueback herring, and White sucker

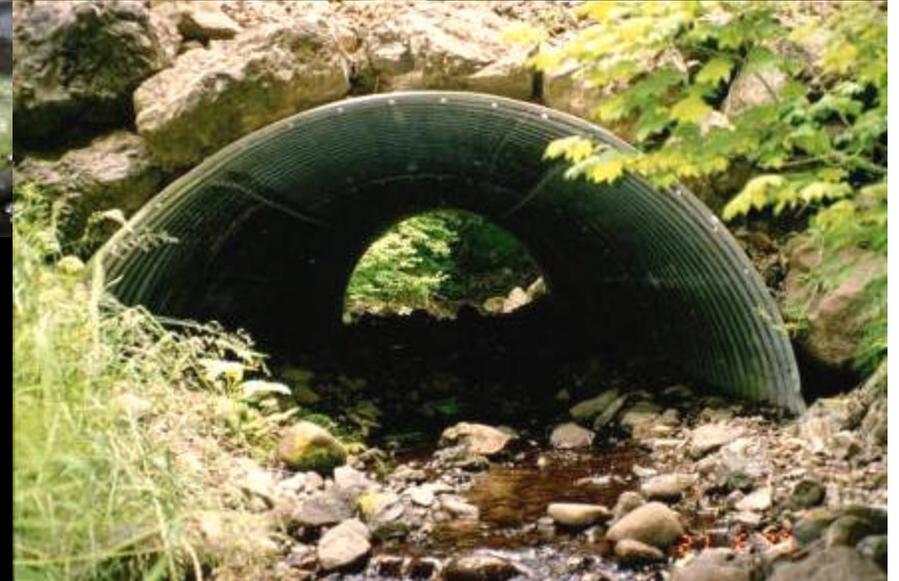
www.streamcontinuity.org/cdb

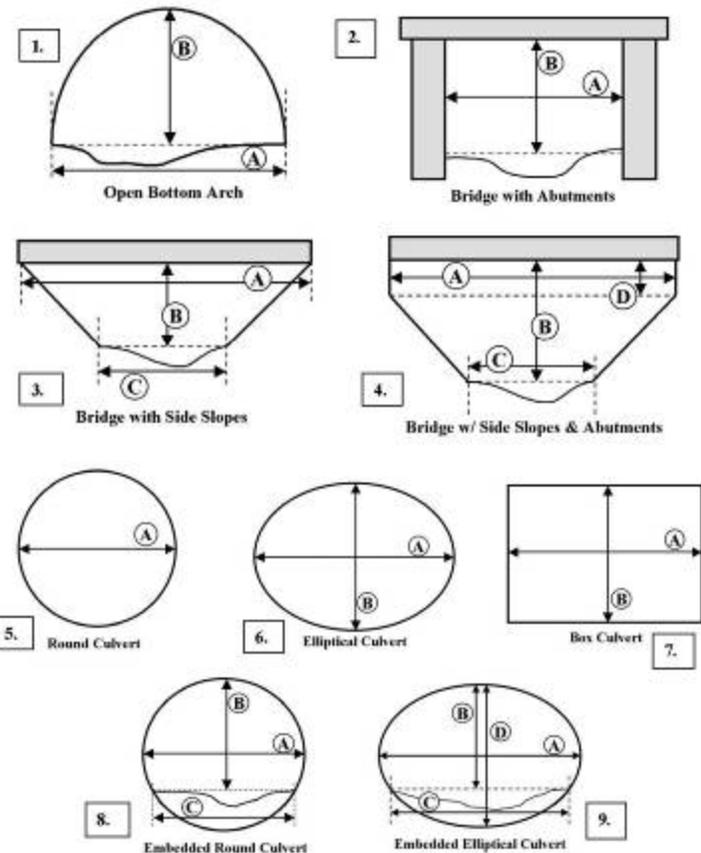
CROSSING DIMENSIONS

Crossing Type (from above): 1. 2. 3. 4. 5. 6. 7. 8. 9. Ford

Upstream Dimensions (ft or m): A) _____ B) _____ C) _____ D) _____

Downstream Dimensions (ft or m): A) _____ B) _____ C) _____ D) _____

Length of stream through crossing (ft or m): _____
