Elba's Wetland Creation Project

February 2006

**Jason Goldstein
Principal Environmental Scientist
Southern Natural Gas Company**

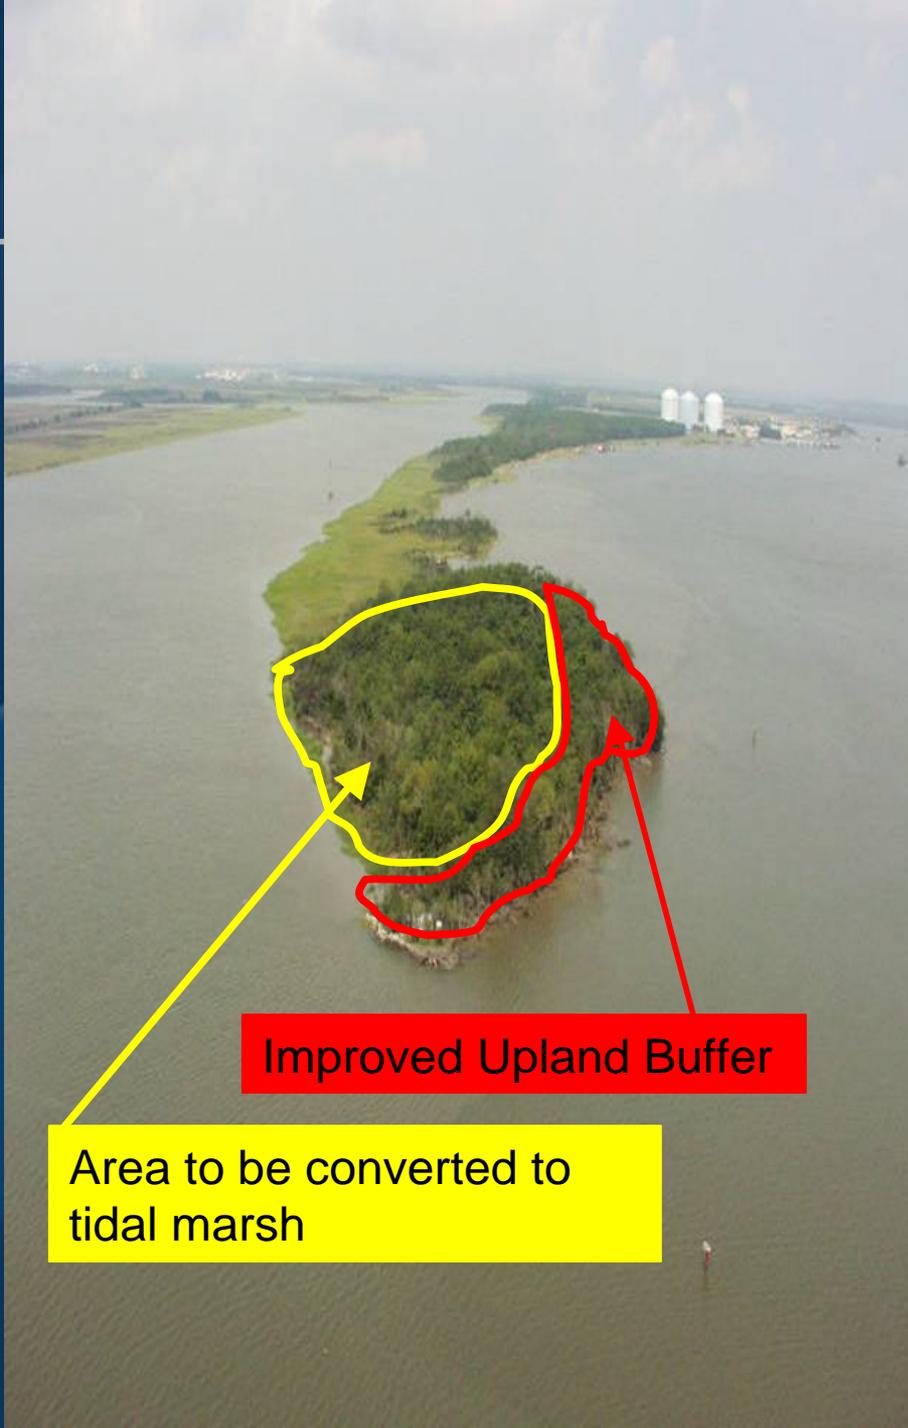
Improved Upland Buffer

Area to be converted to tidal marsh

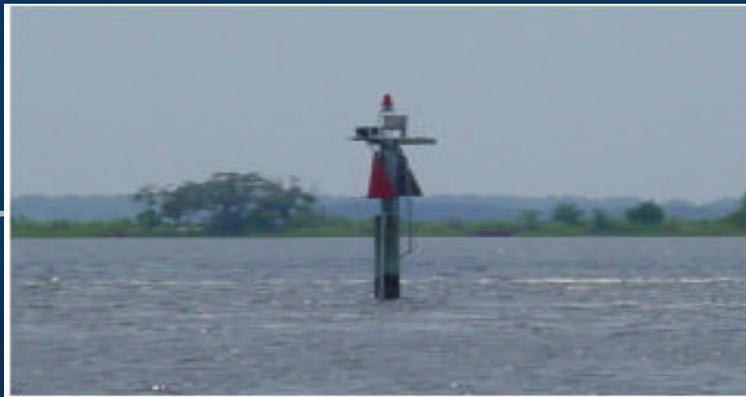
Tidal staff gauge for piezometer reference

- Install hydrological monitors and piezometers to determine tide and flood elevations
- Survey and study existing topography and hydrology to design your grading plan

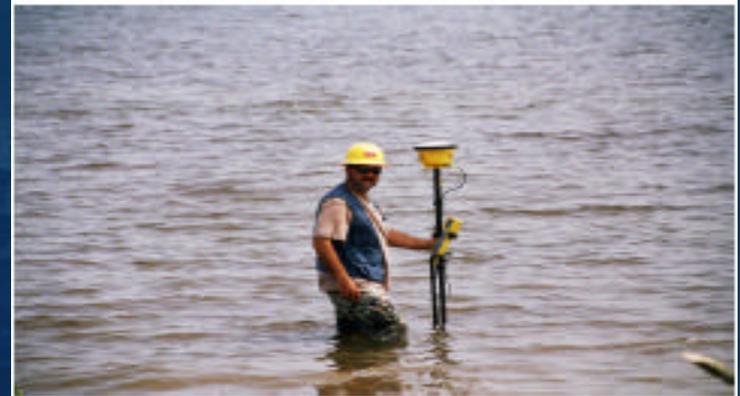
Using survey-grade GPS to determine elevations of restored marsh

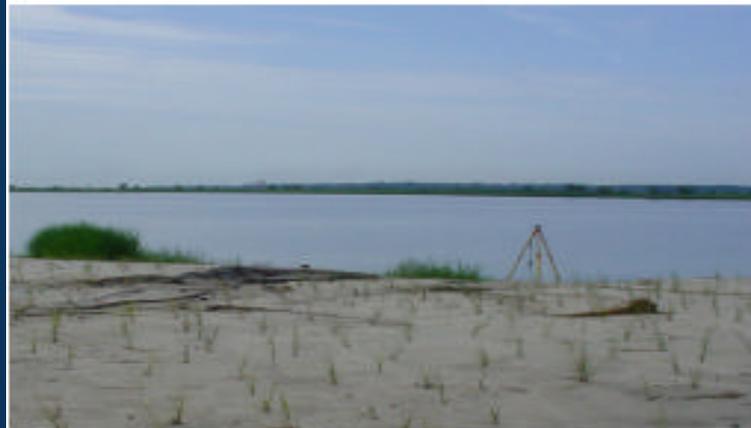
Transit for elevating tidal staff gauge

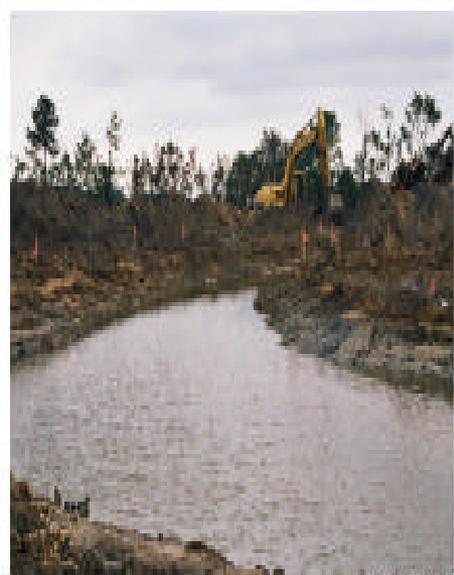
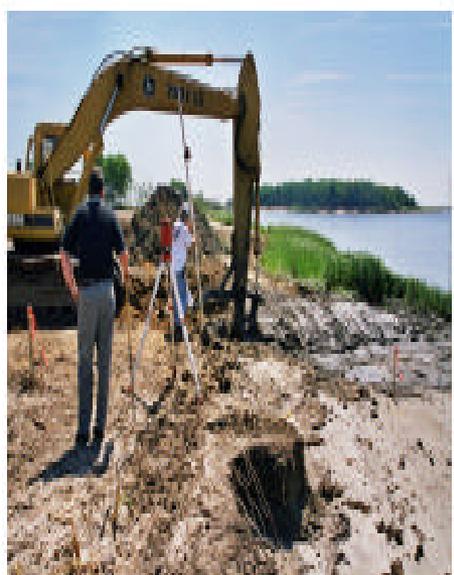
Dredging feeder creek

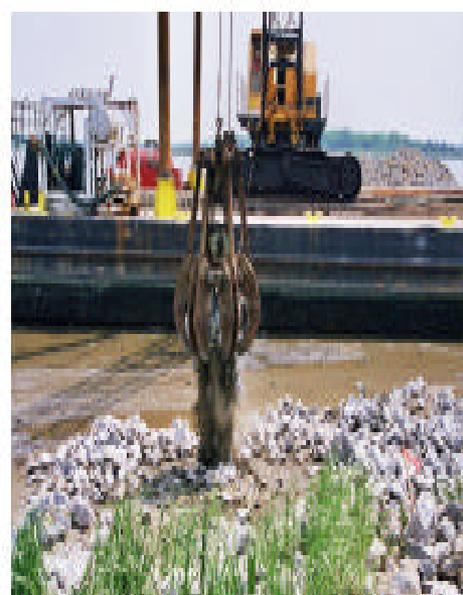
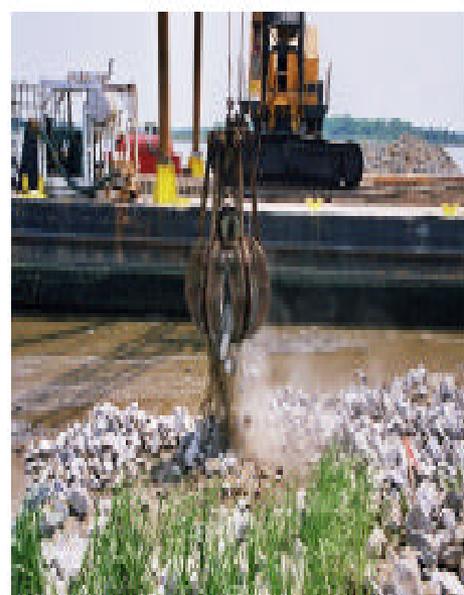
Revetment installation at mouth of constructed feeder creek

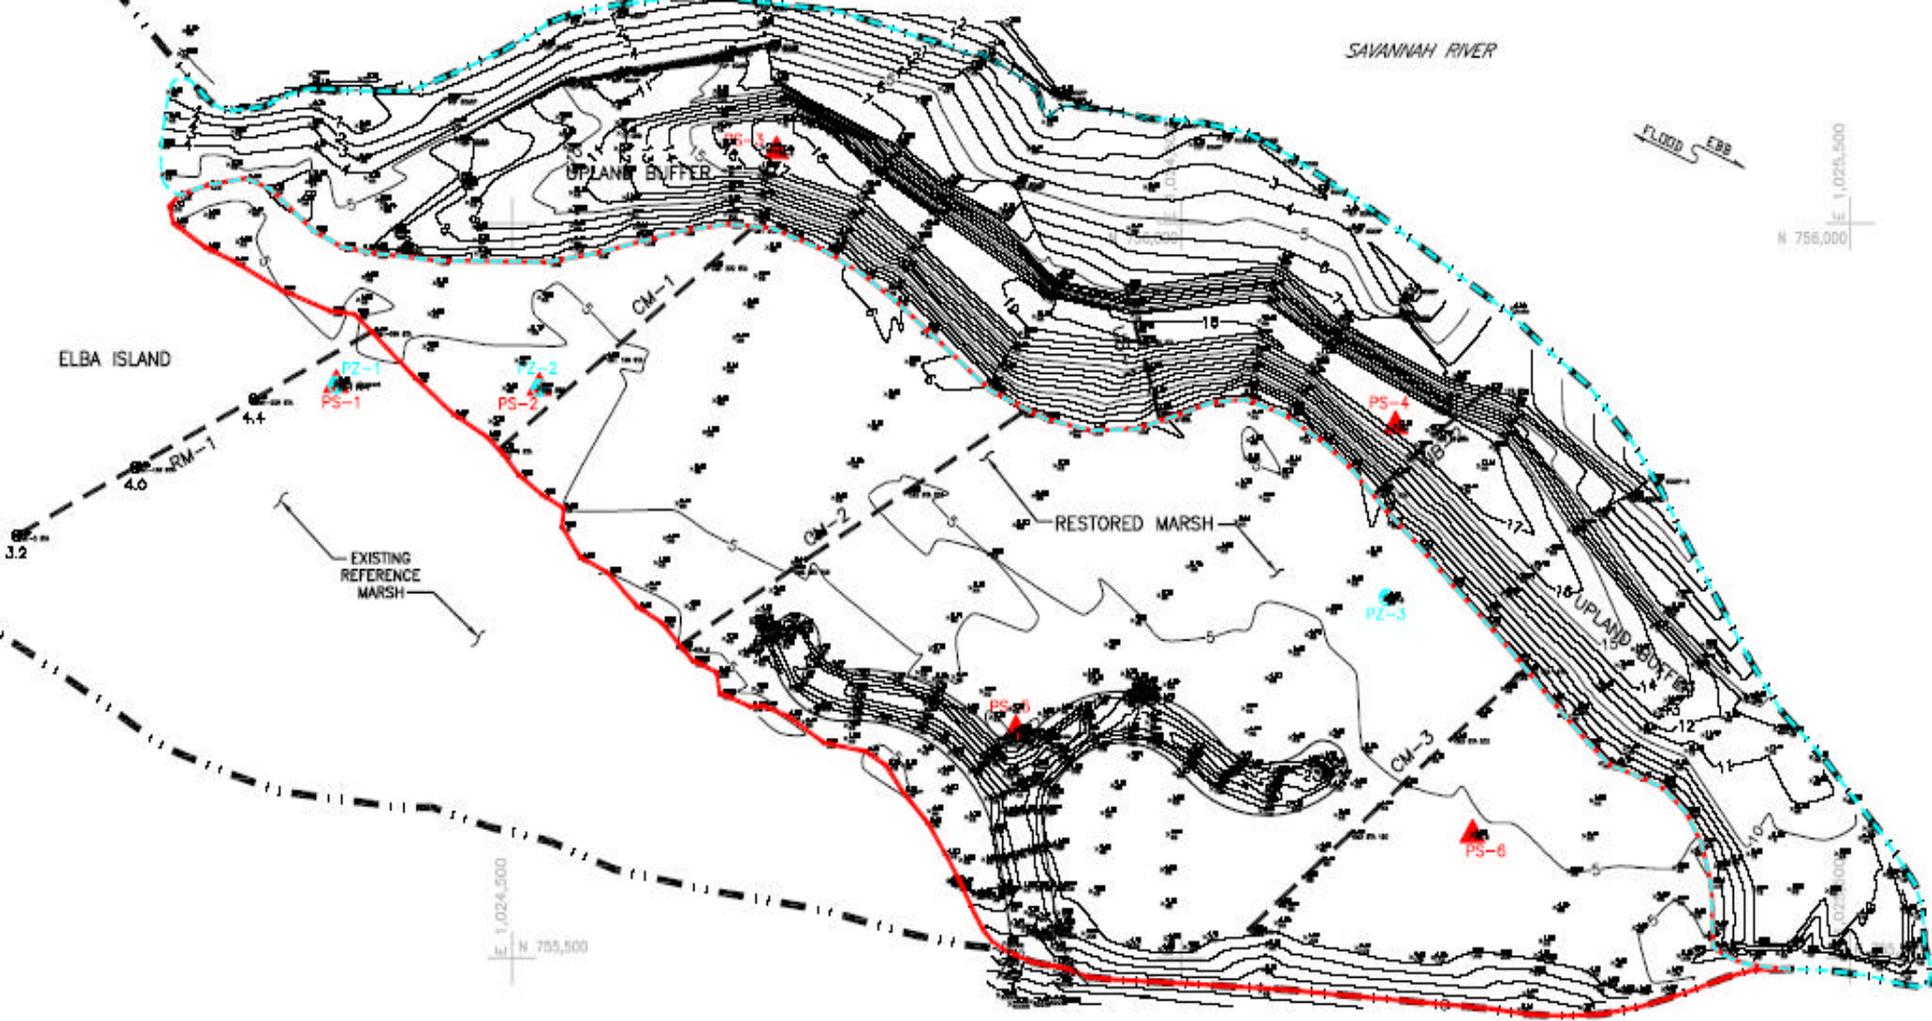
Contour Map As-Built Drawing February 17, 2004

- 1 — AS-BUILT 1' CONTOUR
- 5 — AS-BUILT 5' CONTOUR
- LIMITS OF RESTORED MARSH (6.54 AC.)
- - - - - LIMITS OF UPLAND BUFFER (5.10 AC.)
- - - - - APPROXIMATE SHORELINE LOCATION
- PZ-1

PIEZOMETER LOCATION
- SG-1

STAFF GAUGE LOCATION
- PS-1

PHOTO STATION LOCATION
- - - - - QUADRAT LOCATION

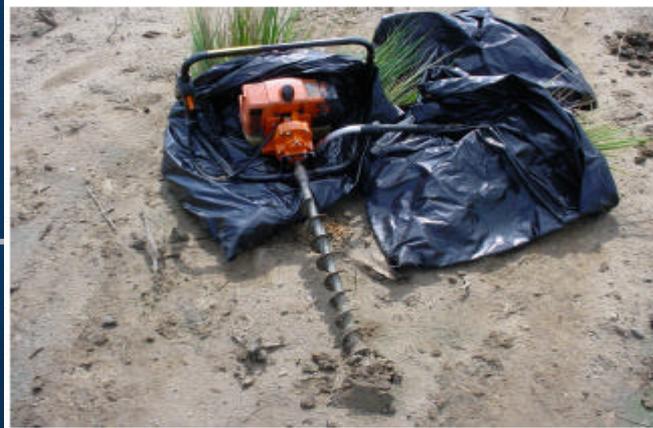
Soil auger and plants in restored marsh

- Planted smooth and saltmeadow cordgrass (*Spartina* sp.)
 - Nursery grown containerized stocks (1.75")
 - Placed on 2 foot centers
 - Except for 3 rows of one gallon or larger containers at water's edge

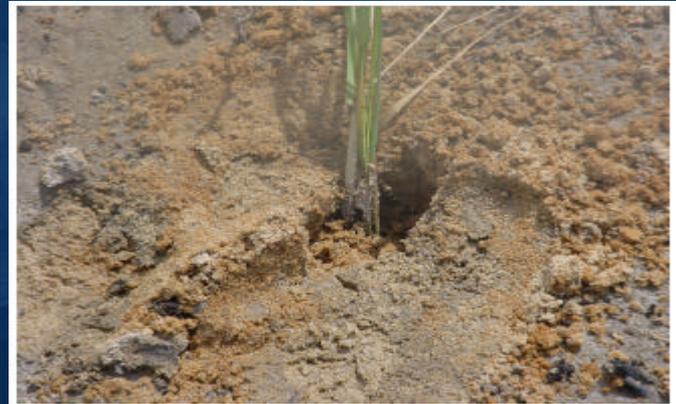
Spartina alterniflora being planted

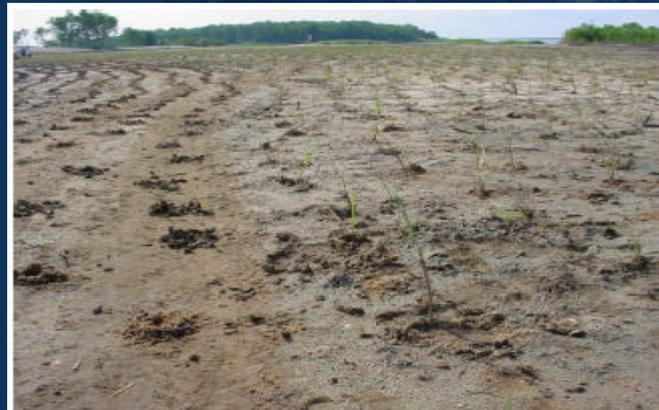
Augered holes and newly planted *Spartina alterniflora*

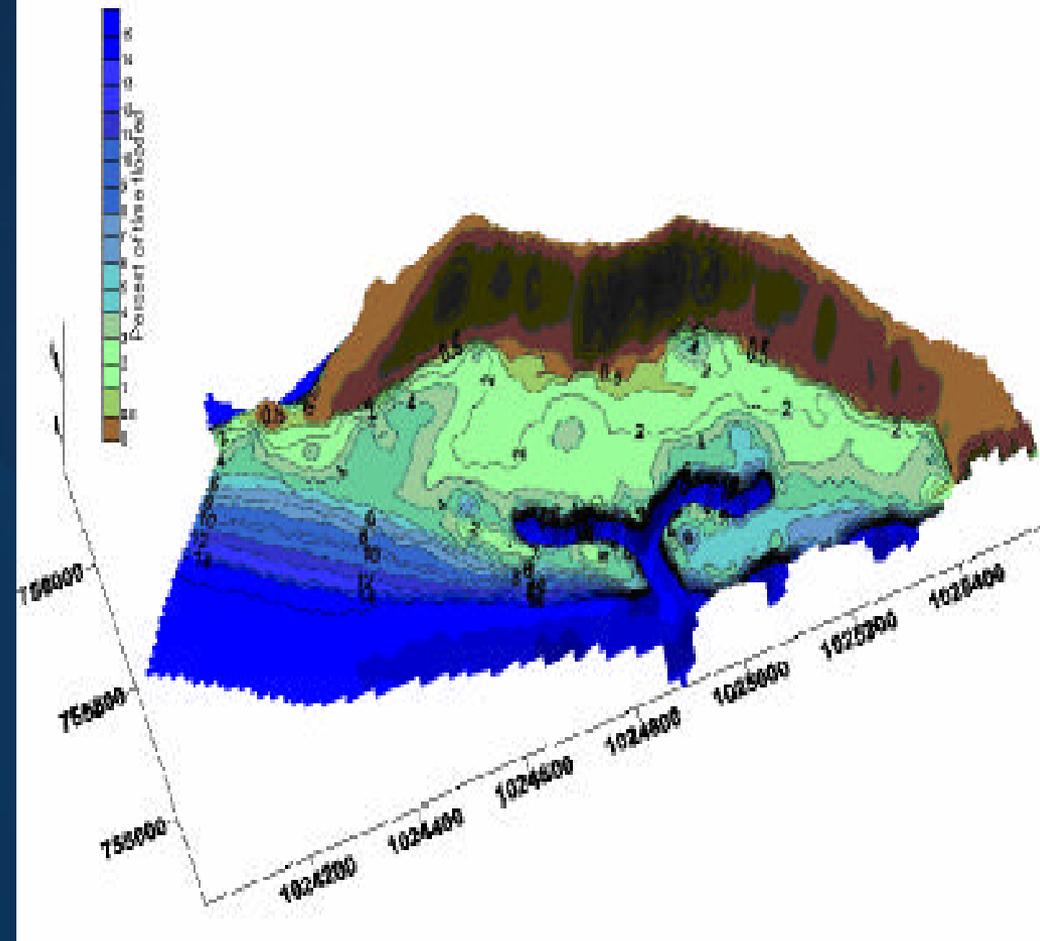
• Figure 10. Flooding Frequency Contours for Elba Island Mitigation Site, View 1 (1 July to 31 December 2003)

- Staff gauges and piezometers continuously record water levels and water table
- Measurements indicate that a diverse marsh system is being created
- Maximizes the opportunity for greater numbers of species to establish
- Overall hydrology is consistent with the reference marsh
- SUCCESS!!!
