Diagnosing Well Related Problems Utilizing Digital Camera Video Recording Technology

Beard, G.H./1 Vendrell, P.F./2

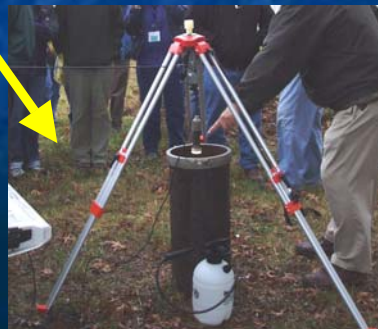
Inspection 2: The second well inspection initiated by the agents was at a private residence and revealed that there was some type of natural formation just below the casing at approximately 320 feet and was emitting some type of gas (possibly carbon dioxide or methane) which in turn was causing the pump to burn up because it was losing prime because of the bubbles. The gas was observed in a bubbling action that was emitted at a crack or fissure along the well wall

Inspection 2: After the agents determined the approximate depth to the phenomenon, they then attempted to determine the type of gas that was being emitted. A field test to trap some of the gas was initiated by installing a plastic bag over the top of the well head and sealing with black electricians tape. This device was then left in place for approximately 20 minutes. The agents observed that the bag was beginning to fill with the gas and after a period of time, atmospheric equilibrium was reached and the bag ceased to fill with the gas. The bag (with the gas trapped inside) was removed and a flame was introduced in order to determine if ignition would occur. When the flame, which was introduced into the bag, was extinguished, it led us to believe that the gas was not methane in nature. Since the flame self extinguished, our hypothesis was that it was possibly carbon dioxide in nature since all oxygen seemed to be excluded from the test device. These are only assumptions since a lab confirmation was not completed on the gas. Once the precise depth to the fissure was discovered, the agents recommended that an additional length of casing be installed that would put the pump below the area of the fissure and the bubbling gases. The pump was then lowered an additional 20 feet below this area which allowed it to prime. Dr. Paul Vendrell, Ag Services Laboratory and water specialist, was on site during the inspection, so it was not necessary to upload the digital video for further inspection and diagnosis. This action was successful.
